## Shaw and Crompton War Memorial

### Heritage Statement

This Heritage Statement has been prepared on behalf of Oldham Metropolitan Borough Council (OMBC) in support of the Listed Building Consent application for the conservation of the Shaw and Crompton War Memorial.

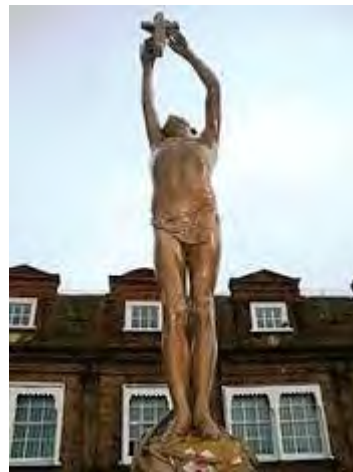
**Gateshead War Memorial**

The bronze patination has degraded and sulphate corrosion staining covers the figure.

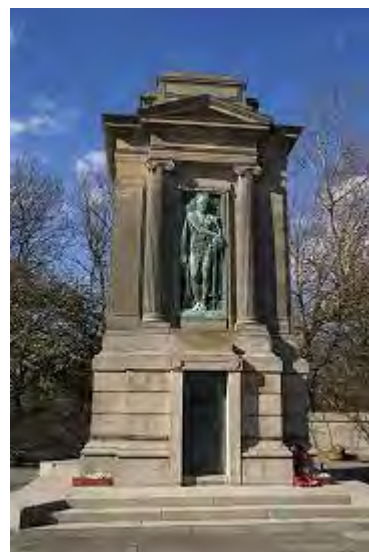
Bronze semi-nude warrior resting on his unsheathed sword framed between two ionic pillars.

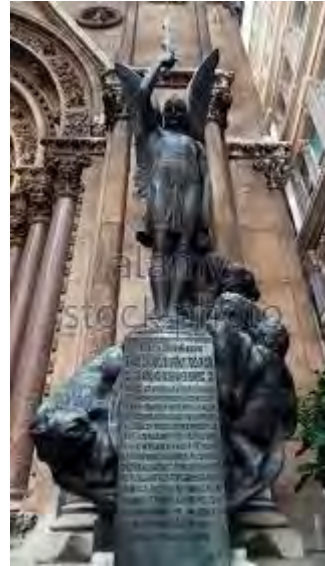
**St Michaels Church  
Cornhill – City of London**

Bronze figure of St Michael surrounded by children and wild animals.

The figure is in a degraded condition however it would appear that the original appearance was of a dark coloured patination.

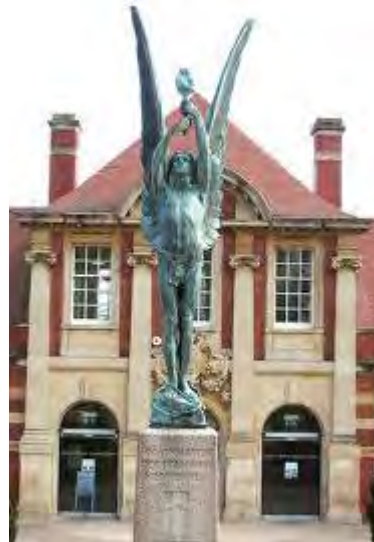
## Great Malvern War Memorial

Bronze winged semi-nude male figure representing youth with upstretched arms holding a torch.

The original patination of the figure has degraded and sulphate corrosion on the surface has turned the figure green in colour.

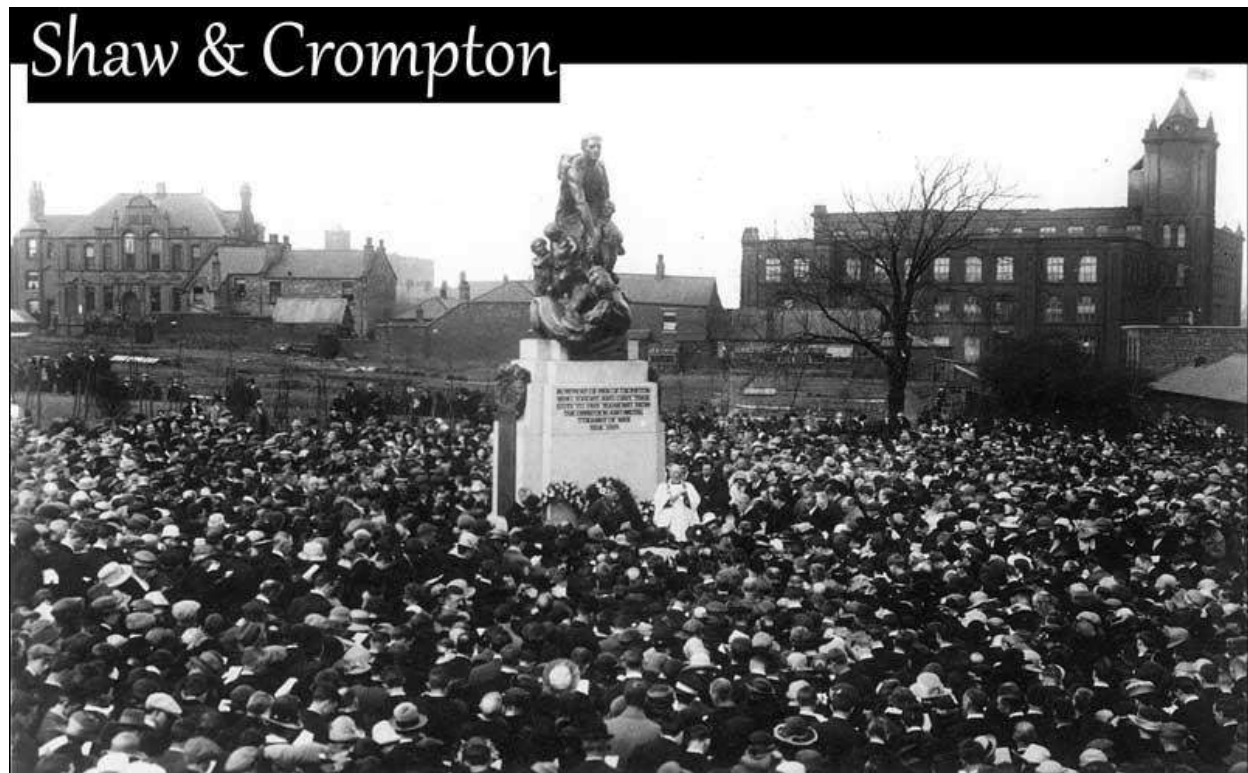
The earliest photograph of the monument at the unveiling ceremony on 29<sup>th</sup> April 1923.

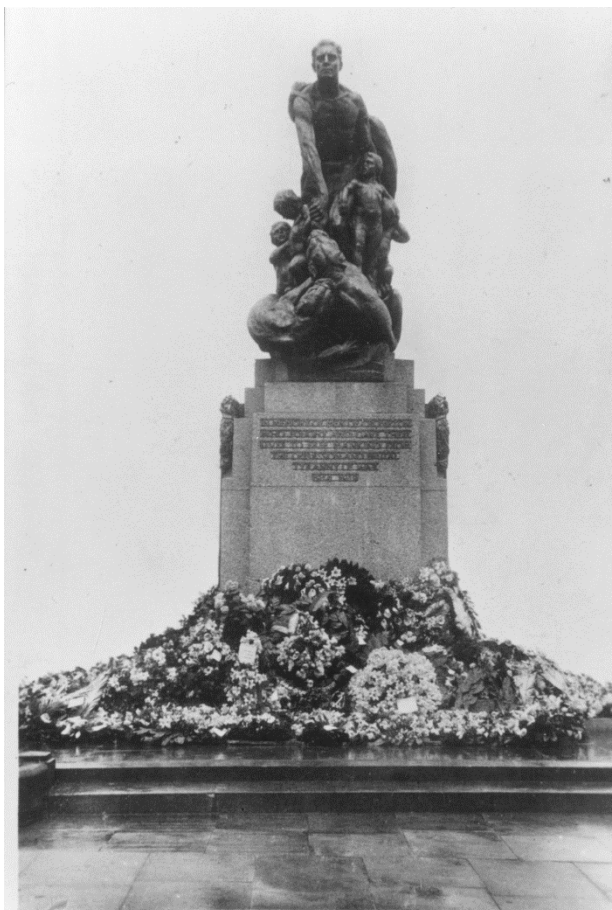
Front elevation of the monument with background removed. Photograph possibly taken after first unveiling as the floral tribute bear great resemblance to photos from that event.

Bronze figures are shown in their original dark bronze patina.

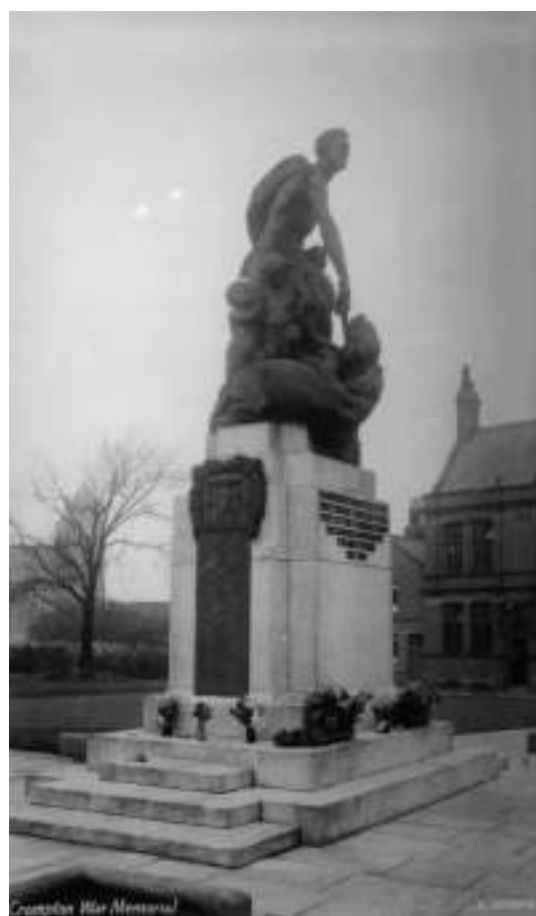
Photograph (undated from the Oldham Archives) believed to be from the 1950's showing bronze figures in dark patina.

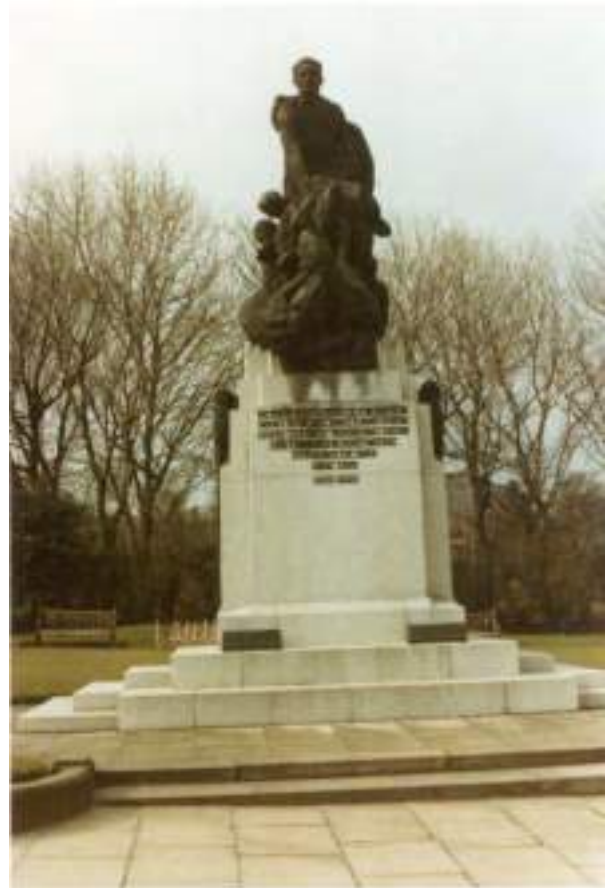
Photograph (undated from Oldham Archives) however believed to be from 1970's showing bronze figures in a dark patina together with staining on the granite stonework under the front of the figures.

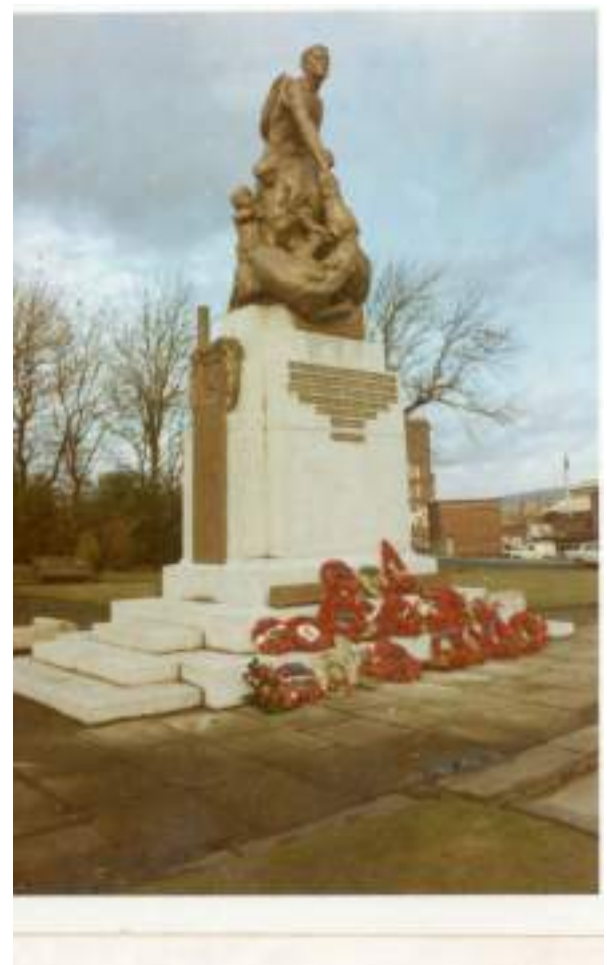
Photograph (undated from Oldham Archives) believed to be from the 1970's however showing lighter patina of the bronze figures. Some staining under the figures remains indicating that this may have been from a previously applied coating to the bronze figures.

Planters are also coloured in a similar colour to the bronze group.

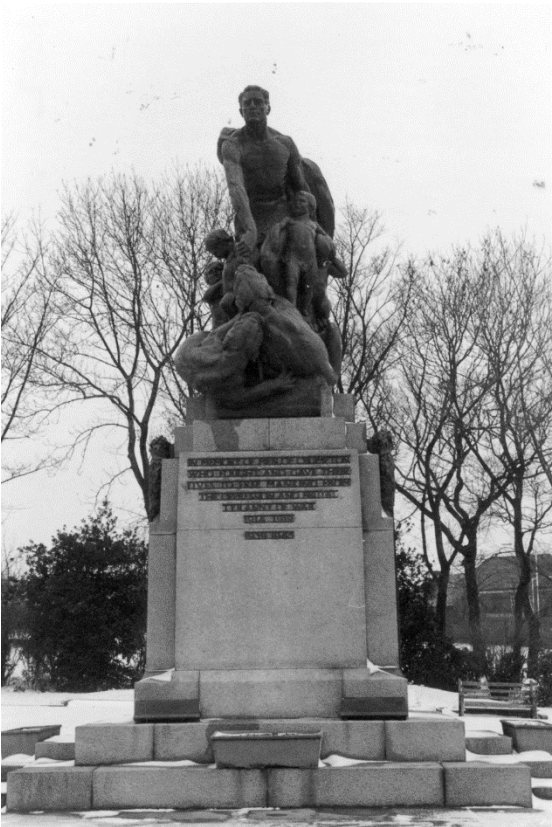
Photograph taken at time of listing by English Heritage. Circa 1987. Bronze figures and plaques are in a lighter colour similar to current appearance.

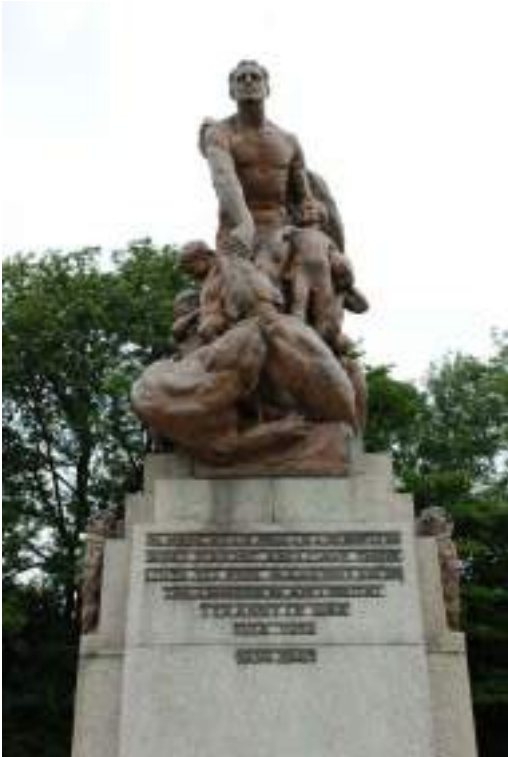
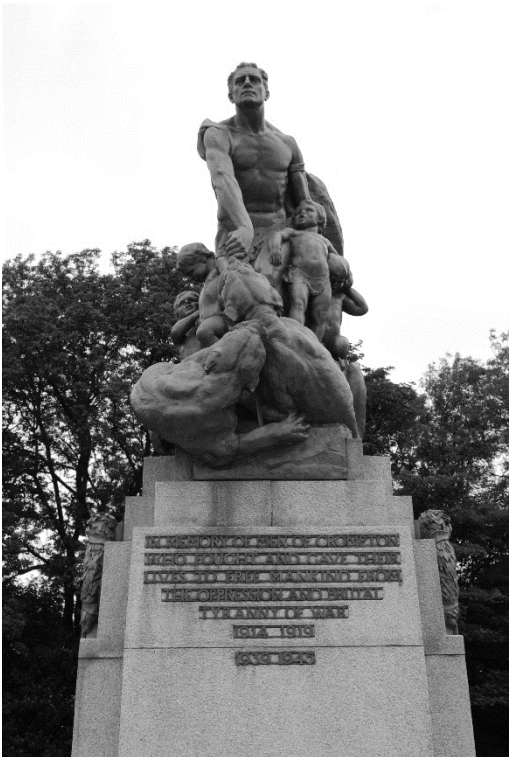
Photograph from 2010 with bronzes in light patina (current colour) in full colour and black& white.

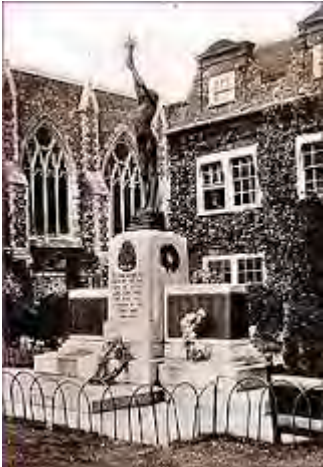
Memorial - Description	Photograph
<p><b>Dover War Memorial</b></p> <p>Although the current patination of the sculpture is a golden brown the original colour of the monument was a more typical dark brown patina – as shown here in the photograph of the monument unavailing.</p>

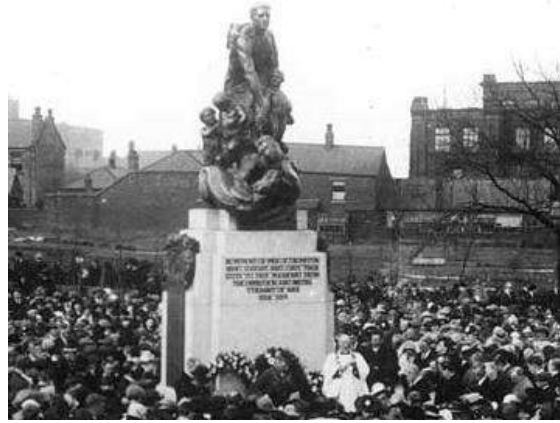
## Crompton

Again although the current patination of the monument is a light brown colour the original appearance of the monument when it was unveiled in 1923 was a dark brown colour.

It is therefore proposed that any re-finishing works to the Crompton Memorial should return the monument to its original dark coloured patina as was the original intent of the artist rather than its current golden appearance.
